Sideslip Anomaly

Summary

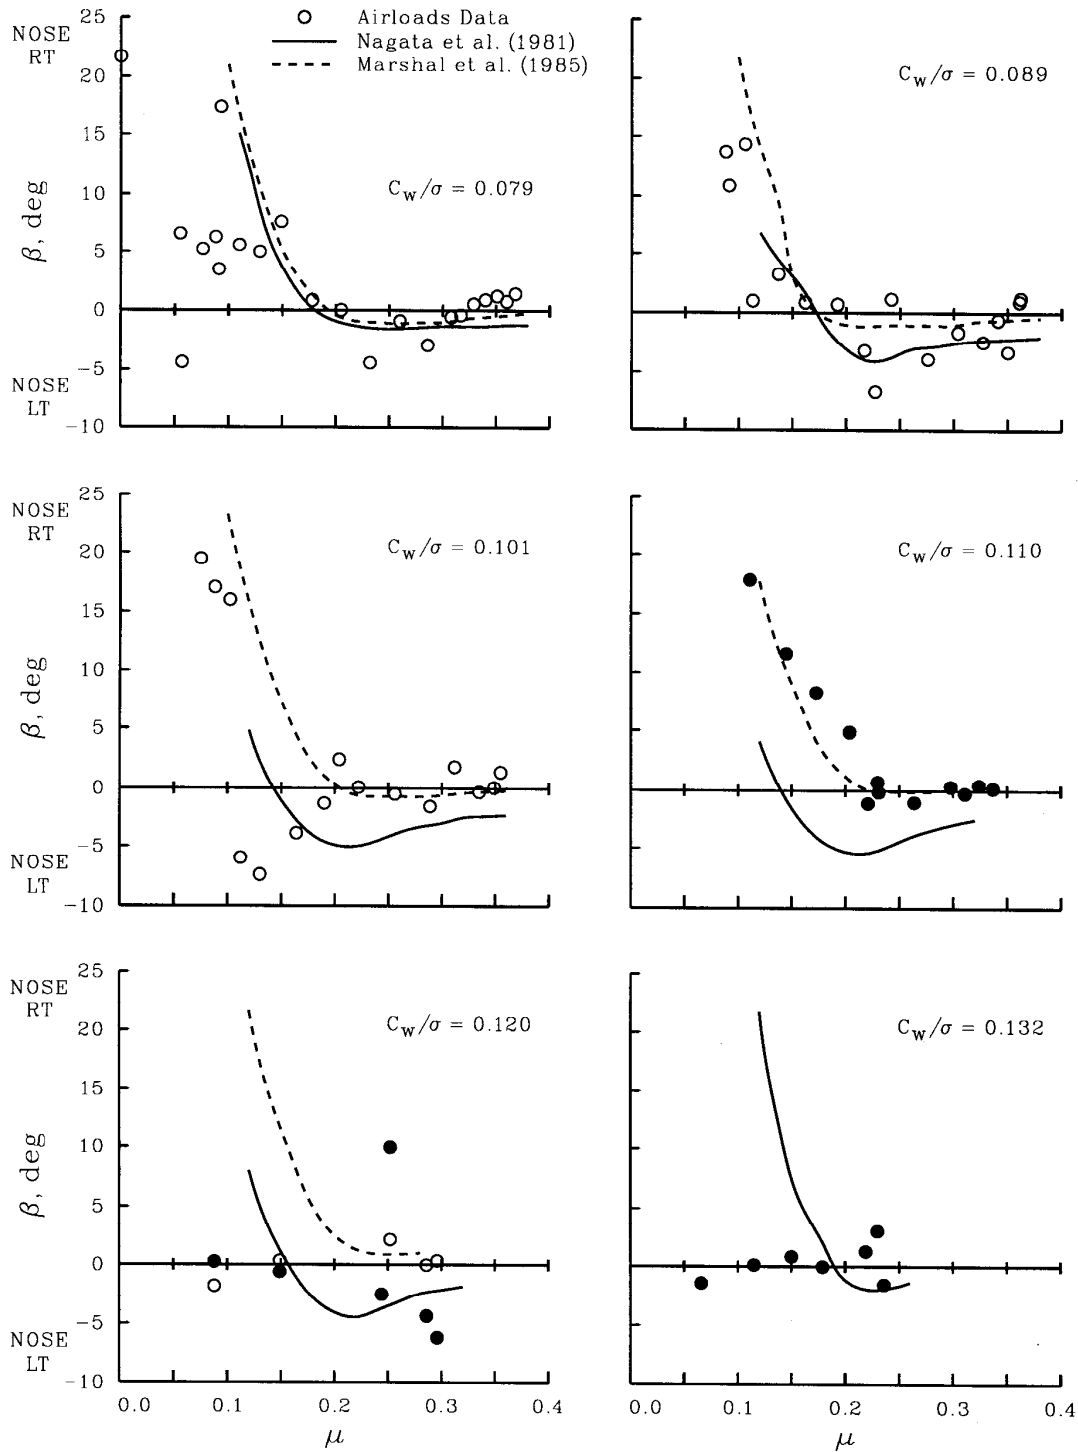
Figure 1 – Comparison of measured sideslip angle for six level flight performance conditions with measurements obtained by Nagata et al. (1981) and Marshall et al. (1985). Solid circles have been shifted by -39.77 deg.

The bias value for the sideslip angle determined in the pre- and post-flight static calibrations for Flights 89 and 90 is significantly offset from all other flights in the Airloads Program. The bias offset of -39.77 deg is quite noticeable in the data. The measured sideslip values shown here for the three highest weight coefficients have been arbitrarily shifted by -39.77 deg on an ad hoc basis. However, this bias shift was not used for all test points as can be seen for five of the airspeeds for $C_W/\sigma = 0.12$. It appears that the bias shift that occurred on these two flights was in some cases intermittent. The cause of this anomaly is unknown.

The bias shift in the pre- and post-static calibrations encountered on Flights 89 and 90 is not seen on any other flight and hence the problem with this bias shift appears to be restricted to these two flights. However, this bias shift did not occur for all counters on these flights and it is possible that a related shift has occurred for individual counters on other flights. No systematic search has been made for other flights to see if this anomaly occurs for other counters. Although other anomalous cases have not been found, the use of the sideslip measurement for other flights needs to be done with some caution.
