Sideslip Bias Error

William G. Bousman
US Army Aeroflightdynamics Directorate (AMCOM)
Ames Research Center
Moffett Field, CA 94035-1000
June 1, 1999

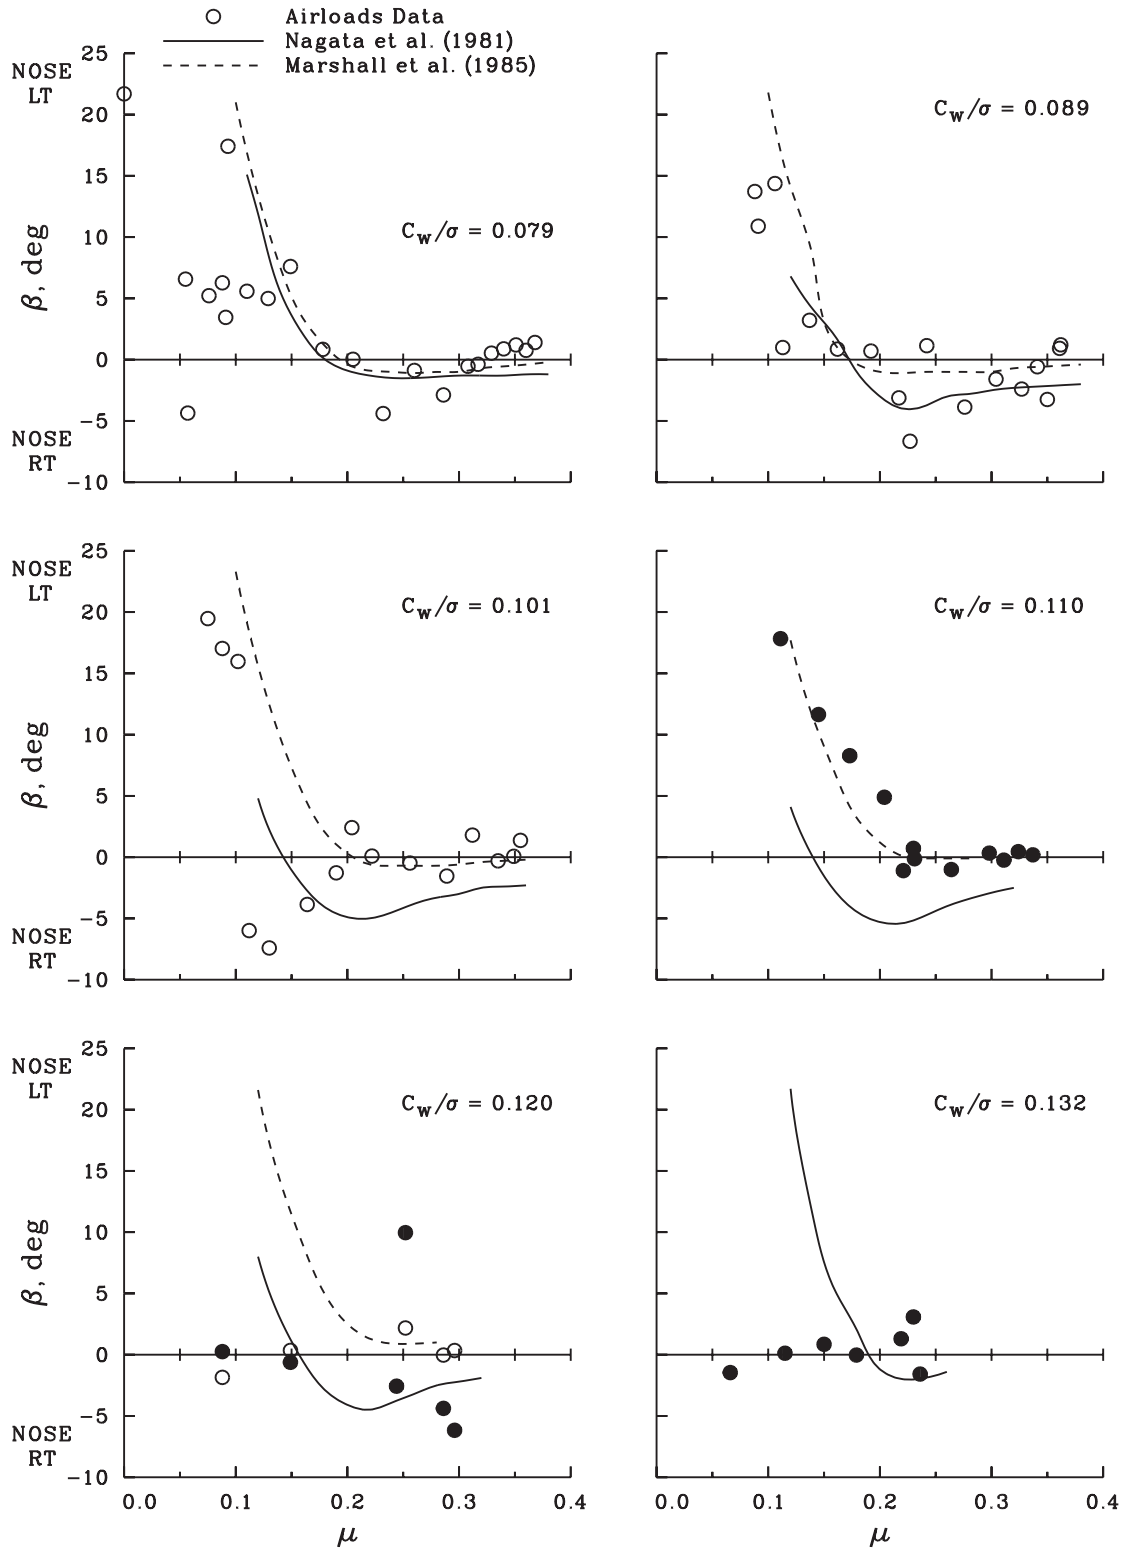
Figure 1 – Comparison of measured sideslip angle for six level flight performance conditions with measurements obtained by Nagata et al. (1981) and Marshall et al. (1985). Solid circles have been shifted by -39.77 deg.

There is a bias error of -39.77 deg. in all sideslip data for the counters on Flight 89 and most of the counters on Flight 90. This bias error occurred because of the inadvertent use of the static calibration value for Flights 89 to 103. The bias error has been corrected for Flights 91 to 103 and for Counters 9023, and 9027 to 9032 on Flight 90. However, the TRENDS data base has not been corrected for Flight 89 and portions of Flight 90.

Presently, the sideslip bias error remains in the TRENDS data base for Flight 89 and portions of Flight 90, and the sideslip requires correction for these counters.
